WHARF

BIOSECURITY MANAGEMENT PLAN

HBRC Certified June 2019

NAPIER
PORT

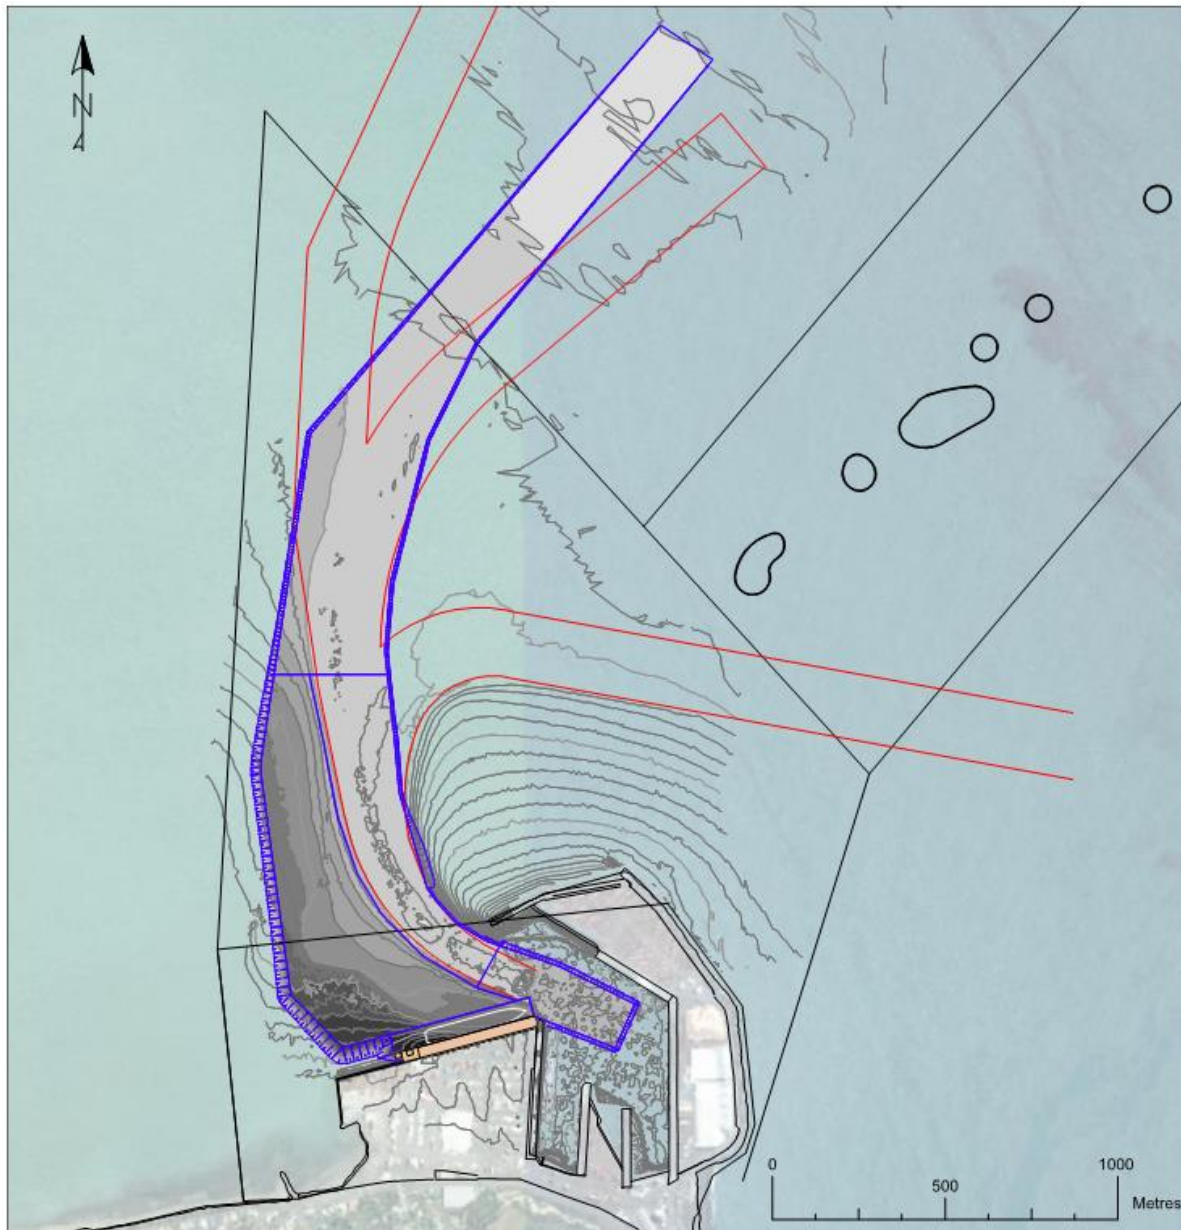
Figure 1 - Project Location

Figure 1 shows the dredge footprint for all stages of the Project. Figure 2 shows the offshore disposal area (ODA), for the Project.

Figure 1 shows the dredge footprint for all stages of the Project. Figure 2 shows the offshore disposal area for the Project.

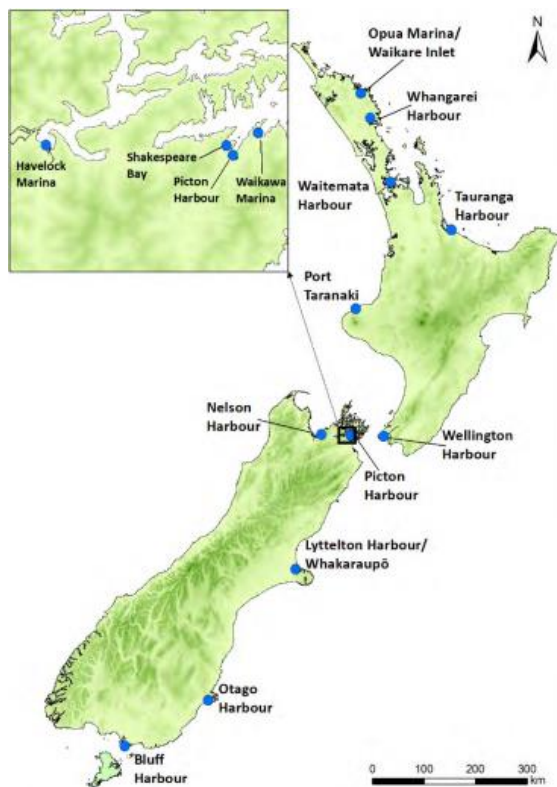
Figure 3. Identified high risk areas

The Marine High Risk Site Surveillance (MHRSS) is a national programme of surveys targeted at the early detection of High Risk marine non-indigenous marine species (NIS), and is part of the Ministry for Primary Industries' (MPI) wider marine biosecurity system.

In addition, any vessel relating to the project that has been layed up or inactive in a high risk identified area, as shown in *Figure 3*, must provide evidence of a clean hull (i.e. dive survey, video evidence, hull clean) prior to departing that high-risk area, to conduct dredging or associated activities on the 6 Wharf project.

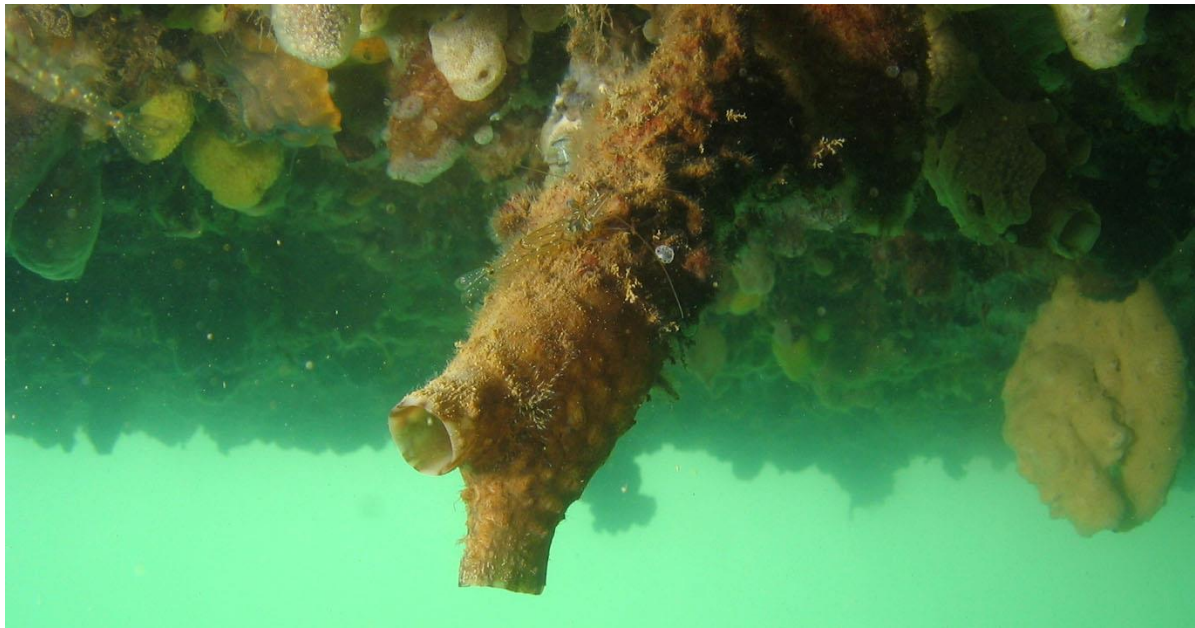
Clubbed tunicate has a long, club-shaped body on a tough stalk. Its surface is leathery, rumpled, and nobbly. They can be brownish-white, yellowish-brown, or reddish-brown and ugly in appearance. Sometimes referred to as a 'solitary' sea squirt because each individual has its own stalk and adheres separately to a substrate. It is known to grow rapidly overseas, reaching densities of up to 500-1500 individuals per square metre. They can live for up to two years and grow up to 160mm long. While Clubbed Tunicate are hermaphrodites they have to have more than one to reproduce because the male and female sex organs mature at different times to avoid self-fertilisation. They release eggs and sperm into the water, where eggs are fertilised. The resultant larvae can float freely for 1-3 days before settling and attaching themselves to a hard surface (e.g., rocks, wharf pylons, marine farm ropes).

The clubbed tunicate can outcompete other species due to it reaching such high densities and being an efficient suspension feeder. As a fouling organism it can decrease the productivity of cultured species and increase aquaculture processing and harvesting costs. It also results in higher fuel and maintenance costs for vessels. In Japan it has caused asthmatic symptoms in individuals who shuck fouled oysters in poorly ventilated areas.

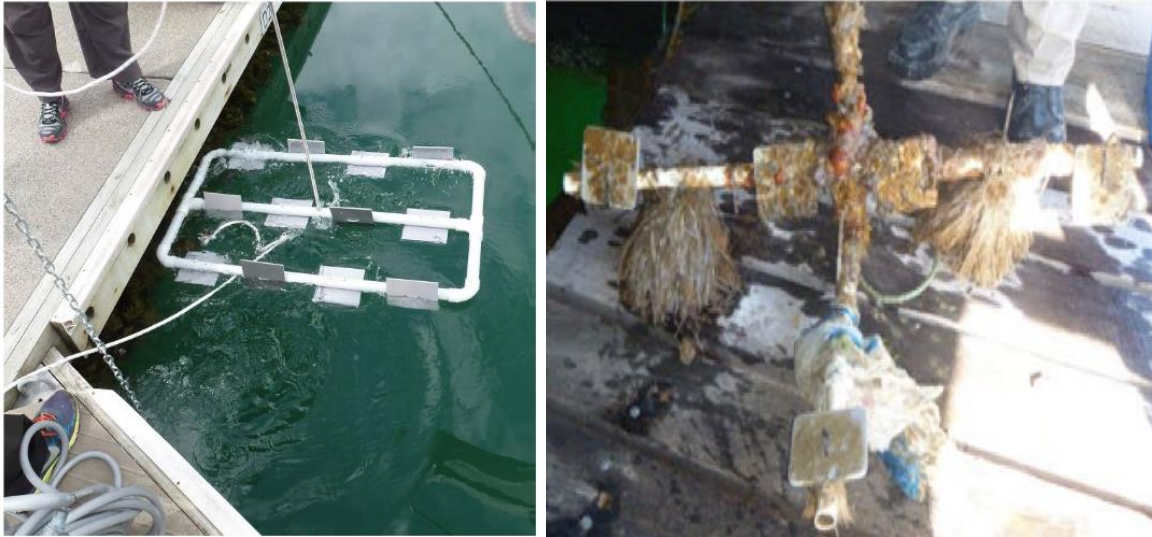
Figure 5 - Examples of settlement plate arrays

It is proposed to install Settlement Plate Arrays for marine surveillance within the Napier Port inner harbour at various locations.
